**DOWNERS GROVE SANITARY DISTRICT
BOARD OF TRUSTEES SPECIAL MEETING**

**WASTEWATER TREATMENT CENTER
TOUR OF PROPOSED CAPITAL IMPROVEMENTS**

May 5, 2026

During the May 5, 2026, Special Board Meeting, District Staff will provide a tour of the proposed capital improvements to the Wastewater Treatment Center (WWTC) as identified in the Downers Grove Sanitary District Facility Plan which was recently completed by Baxter & Woodman. The Facility Plan split the recommended WWTC capital improvements into four phased projects. The tour will only cover projects planned to be constructed under the first three phases as those projects have immediate needs and/or regulatory deadlines.

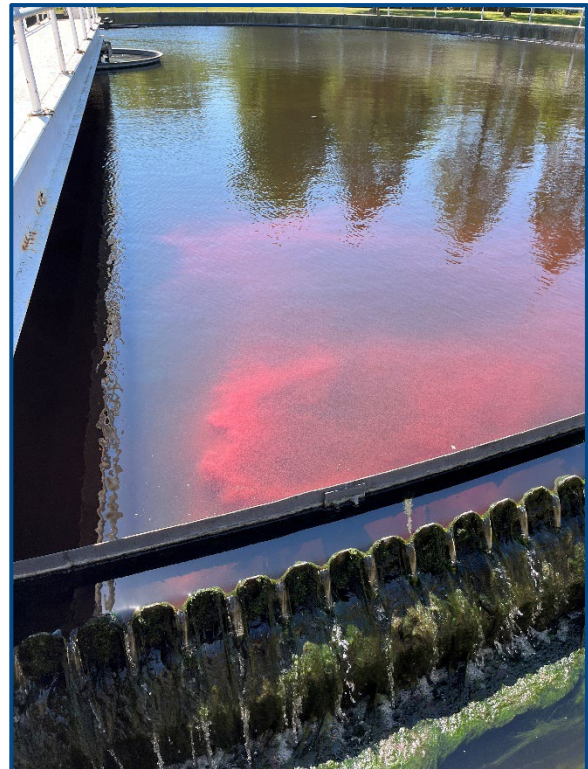
Intermediate Clarifiers 1 – 3 (1972)

- The extra clarification process between the secondary clarifiers and filtration is not typically needed. At this facility, it provides too much treatment time during summer, low flow conditions and cultures red worms. This is a sign of old sludge age, which can lead to other biological process problems in the aeration tanks where the sludge is returned.

- When treating excess flow, dechlorination is not available for Clarifiers 2 & 3, thereby making chlorine residual limits difficult to meet while also complying with fecal coliform limits.

- Due to the intermediate clarifiers being full of unchlorinated secondary effluent at the beginning of an excess flow event, fecal coliform excursions occur during quick, high intensity wet weather events.

- Removing the intermediate clarifiers from the complete treatment process train would address this issue. However, this cannot be done unless the performance of the secondary clarifiers is improved as the secondary effluent occasionally plugs the downstream filters when sent there directly.

- Keeping the intermediate clarifiers in the complete treatment process train limits the potential options for future filtration equipment downstream due to the

additional head loss required for the wastewater to flow through the intermediate clarifiers.

- Remove the intermediate clarifiers from the complete treatment process train and only use them for excess flow treatment in the future. (This can only be done after the improvements to secondary clarification are made.)
- Provide dechlorination (Note: Costs included under dechlorination)

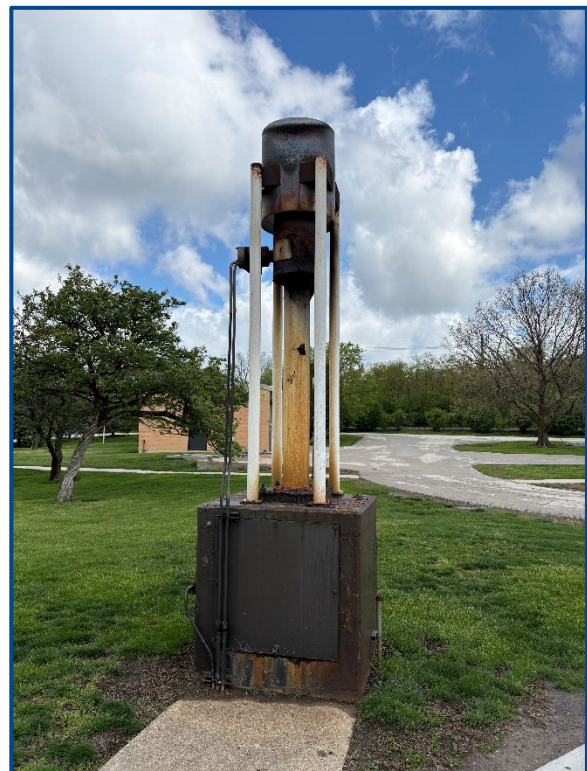
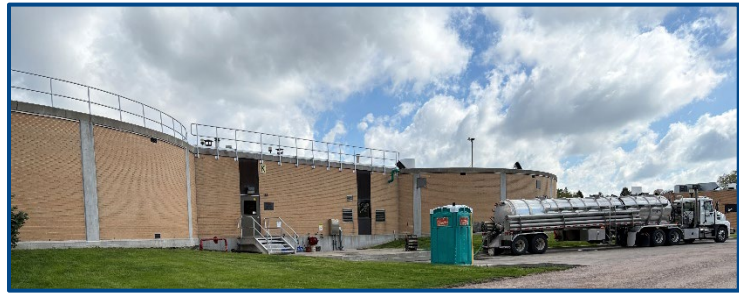
- The 2025 Biosolids-Digestion Study Technical Memorandum hypothesized digestion in Digester 4 would improve by reducing the amount grease sent to it and replacing

the mixing system. To maintain adequate digester gas production, the memorandum recommended that a portion of the grease be digested in Digesters 1 & 2 instead of Digester 4.

- Since the District started accepting hauled grease waste, the Digester 4 Heat Exchanger cannot keep Digester 4 at the required temperature, and the Digester 5 Heat Exchanger has been used to supplement it.

- MCC 14 should be replaced due to its age. MCC 14 currently has more connected load than the incoming feeder capacity. The MCC should not be in the heat exchanger room where it is currently located due to the high temperatures in the room.

- All rooms in the Digester 4 & 5 Control Building require explosion proof electrical installations per the current safety code. The electrical installations in the basement and the heat exchanger room will need to be brought up to code when the MCC is replaced.

- The digester covers are the end of their useful life. Staff frequently monitor and repair holes in the Digester 5 cover.
- The 2023 Code Review report recommended that guardrails be installed around the digesters and the roof of the control building.

- Guardrails have been installed on the Digester 4 walls and the control building roof.
 - Due to the vertical travel of the gas storage cover, the guardrails will need to be mounted on the Digester 5 Cover instead of the digester wall. Due to the age and condition of the cover, the guardrails cannot be welded onto the cover.

- The waste gas burner is significantly deteriorated, and the controls need to be replaced.

- Replace Digester 4 Heat Exchanger
- Replace the MCC, install the new MCC in a new electrical room, and address any additional electrical code issues
- Replace the digester covers
- Replace Digester 4 mixing system
- Remove the waste gas burner and install a new waste gas burner to replace both the Digester 3 and Digester 5 burners

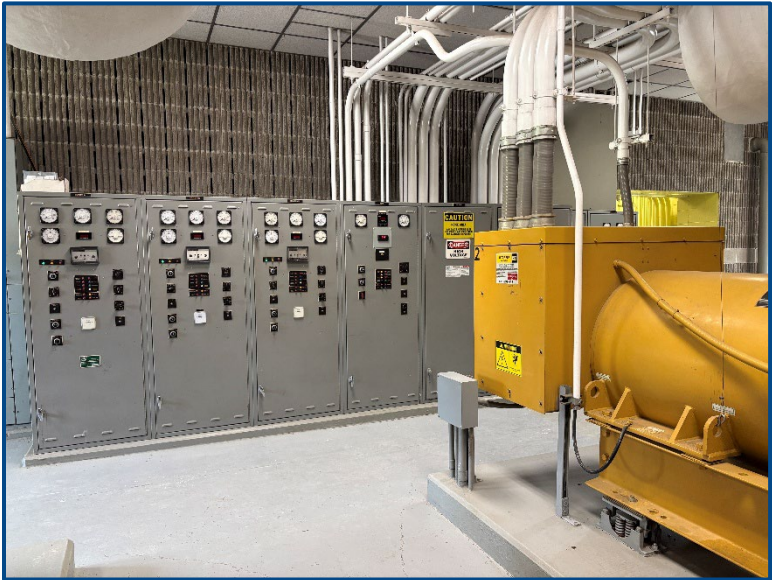
- The manufacturer will stop carrying parts for the emergency generators within five (5) years.
- The controls are obsolete.
- The insurance company will not provide pollution coverage for the diesel storage tank beyond the State required minimum due to the age of the tank.
- The utility (ComEd) automatic throw-over switch (ATO) is obsolete.
- Both utility power sources come from the same utility substation and therefore do not meet IEPA’s requirement for redundant power sources.

- Replace emergency generators
- Install new above ground diesel tank
- Remove the utility ATO switch, converting to one utility power source
- Replace MCC 12

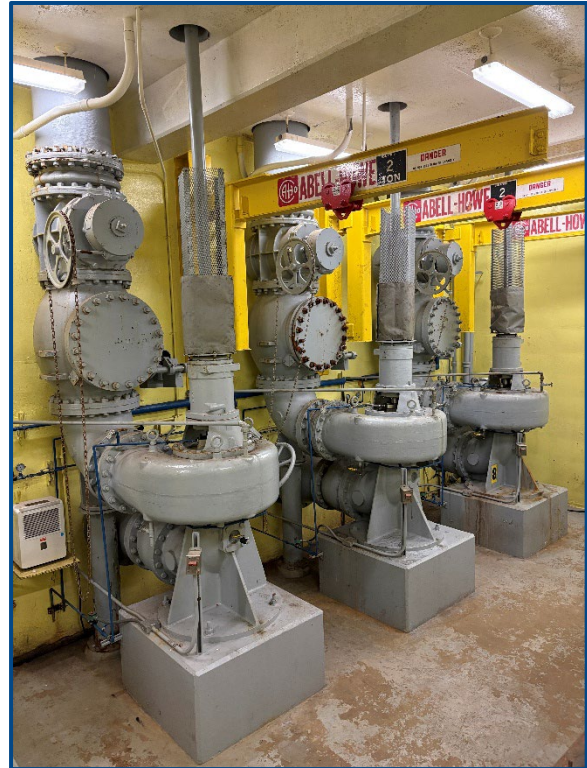
Excess Flow Submersible Pump Station

- Built in 1997
- Pumps 10 - 12

- Pumps, MCCs and valves are past their useful life.
- The manufacturer of Pumps 1 – 8 provides limited support with major parts no longer being available.

- Replace Pumps 1 – 9
- Replace suction and discharge valves for Pumps 1 - 9
- Replace the MCCs in both pump stations

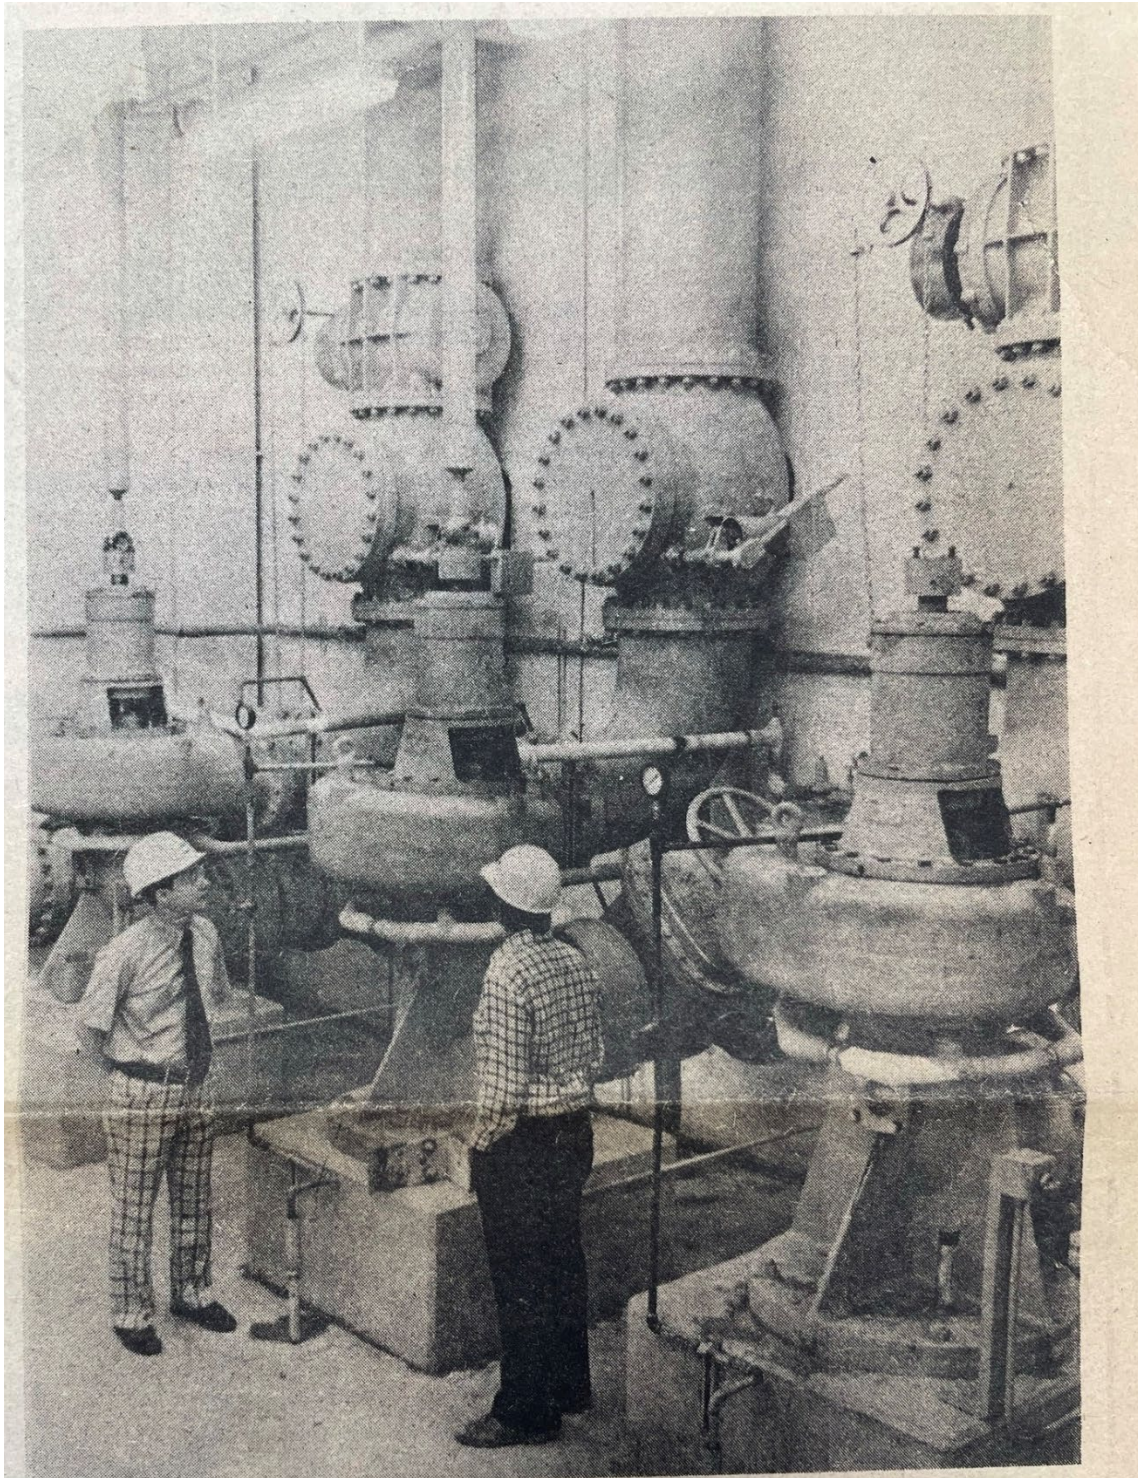
JIM PAPPAS, Sanitary District manager and Asst. Superintendent of Waste Water Treatment Ralph E. Smith are dwarfed by 3 of the 5 new raw sewage lift pumps. The pumps which lift raw sewage at the beginning of the treatment process, are capable of discharging 7,500 gallons per minute.

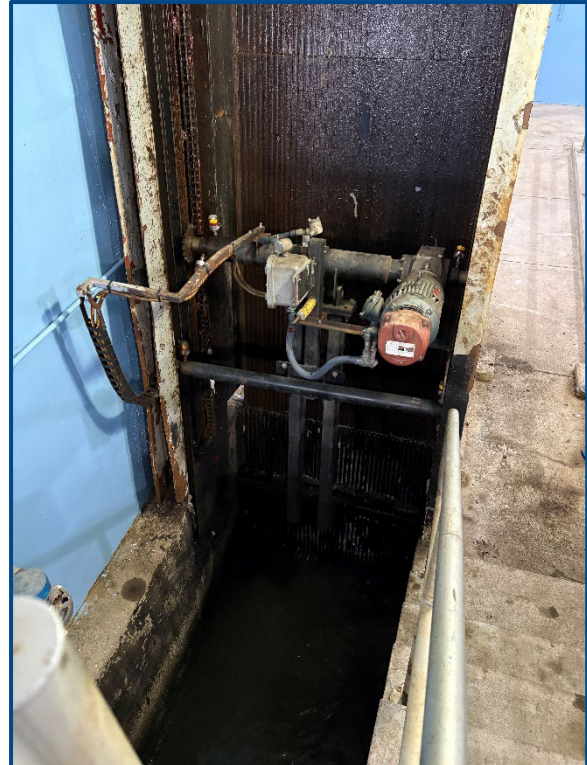
Mechanical Bar Screens

- Two (2)
- Installed in 1984
- 1” wide openings
- Mechanically cleaned

- Parts are obsolete. Staff have had parts fabricated to keep the screens in operation.
- Bar rake motors are non-submersible, requiring staff to turn them off during high flows, resulting in backup of incoming wastewater as screens become blinded.
- Due to hydraulic issues, the screens are often bypassed during high flows, resulting in debris plugging downstream sludge lines, among other issues.
- Finer bar screens are needed to protect future downstream phosphorus removal processes.

- Replace the screens with four (4) new screens with smaller openings. (Smaller openings create more head loss and thereby more screens are needed to maintain the existing hydraulic profile in the upstream sewers.)
- Expand the building to the south to house the two (2) additional screens
- Construct a new dedicated electrical room

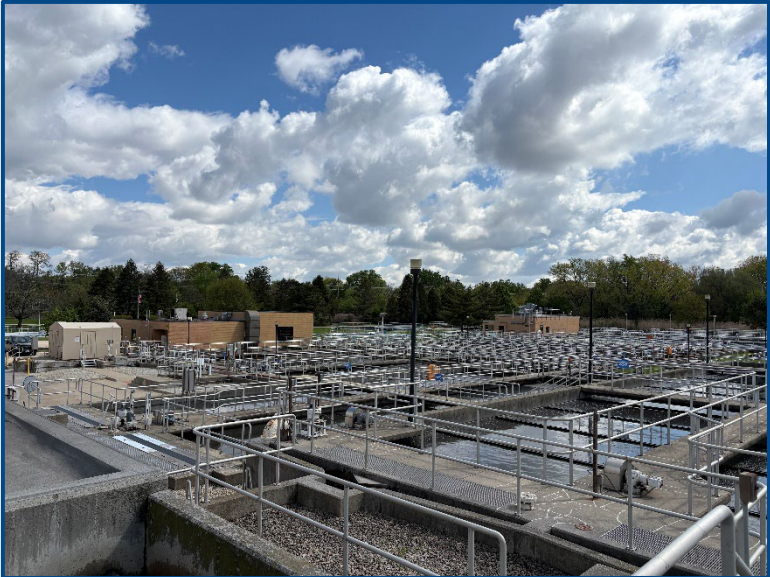
- Performance is inconsistent across clarifiers due to varying depths and dimensions and the inability to split flow evenly.
- Concrete on Clarifiers 1 – 6 is spalling and corroding. Concrete on Clarifiers 1 – 4 was patched recently as a temporary measure to gain more life out of the tanks and make the walkway safe.
- Due to the lower elevation of Clarifiers 1 – 4, a single clarifier cannot be removed from service as it will be back filled from the neighboring clarifier during high flows.
- A representative location to sample primary effluent is not available, making downstream process control more difficult.

- Replace Primary Clarifiers 1 – 6 with three (3) new rectangular clarifiers at the same elevation and of similar capacity as Primary Clarifiers 7 – 9.
 - Raising the water level of the primary clarifiers provides hydraulic “space” for a primary effluent and return activated sludge (RAS) division structure and for future nutrient removal tanks.
- Replace equipment in Primary Clarifiers 7 – 9.

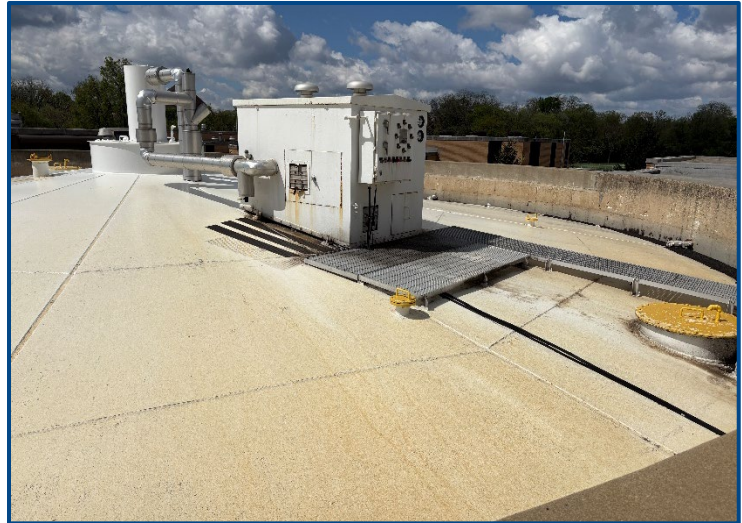
- Built in 1956
- Digester 2 Cover (1986, floating)
- Digester 2 Mixing System (1986)

- Built in 1956, expanded in 1963 and 1986
- Digester 1 Heat Exchanger (1963)
- Digester 2 Heat Exchanger (1986)
- Miscellaneous sludge pumps
- Miscellaneous digester gas equipment and appurtenances
- MCC 11 (1987)

- The digester covers are at the end of their useful lives. One hole in Digester 1 Cover has been patched recently.
- The 2023 Code Review report recommended that guardrails be installed around the digesters and certain accessible areas of the control building roof.
- The 2025 Biosolids-Digestion Study Technical Memorandum recommended a portion of the accepted grease be co-digested in Digesters 1 & 2. When the District pilot tested accepting grease into Digesters 1 & 2 around 2012, the gas takeoff piping could not handle the resulting increase in gas flow, and a cover tilted. The gas take-off piping will need to be increased with larger diameter piping before grease can be processed in Digesters 1 & 2.
- The digester mixing system on Digester 2 is very ineffective and has reached the end of its useful life.

- The Digester 1 & 2 Heat Exchangers are at the end of their useful lives.
- The 2023 Code Review report recommended that the stairs to basement be replaced due to their condition and that the guardrail at the top of the stair opening be replaced with a taller guardrail. The report also noted that the clearance between the guardrail and the Digester 1 Heat Exchanger control panel does not meet the code required minimum.

- The MCC is in the hot CHP 1 room and should be replaced due to its age.
- The basement and heat exchanger rooms in the Digester 1 & 2 Control Building require explosion proof electrical installations per the current safety code. The electrical installations in these spaces will need to be brought up to code.

- Digester gas piping from this control building is routed in the tunnel system. Due to the potential for digester gas leaking into the tunnels, the safety code requires a combustible gas detection and alarming system and a fire alarm system in the tunnels. Potential rerouting of the digester gas piping outside of the tunnel system should be reviewed.

- Replace the digester covers
- Add guardrail around Digesters 1 & 2 and at accessible areas on the control building roof
- Replace digester gas take-off piping with larger diameter piping
- Replace the Digester 2 Mixing System
- Replace the heat exchangers
- Replace the MCC
- Address additional electrical code issues

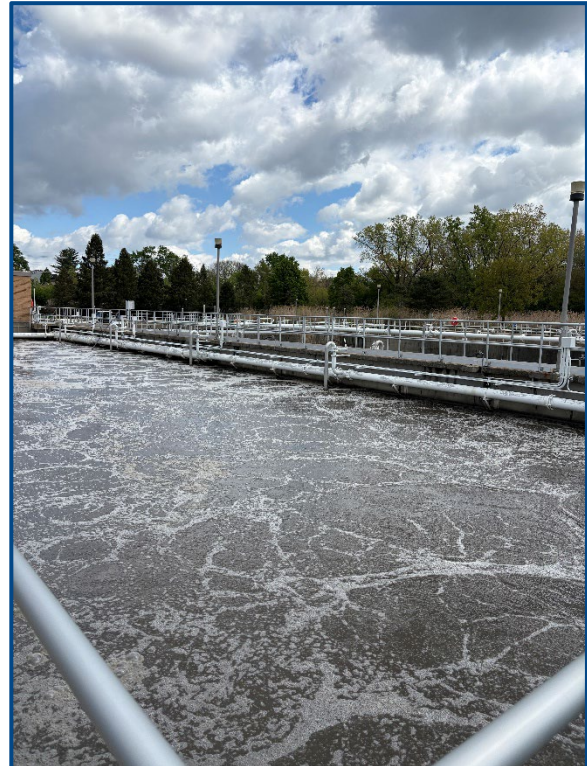
- Built in 1972, expanded in 1986
- MCC 4 (1972, expanded 1986)
- Centrifugal Blower 6 (1986)
- Turbo-blower ABS#1 (2008)
- Centrifugal Blowers 7 & 8 and Turbo-blower ABS#2 (to be replaced with 2 new turbo-blowers in 2026)

- The concrete on Aeration Tanks 1 – 7 is deteriorating.
- Aeration Tanks 1 – 7 are shallower and smaller than the newer aeration tanks, limiting their potential future use.
- Influent flow and RAS are not evenly distributed across the aeration tanks due to upstream hydraulic limitations and the multiple RAS discharge points from two different RAS pumping systems.
- Even distribution of air across all four aeration tanks is difficult to control. (This is likely also impacted by the above-mentioned uneven distribution of influent flow and RAS.)
- Slug loads of high strength recycle streams impact the plant's ability to always meet its ammonia limits.
- Total phosphorus limit of 0.35 mg/L will become effective May 1, 2040, with process improvements required to be in operation by May 1, 2038.

- Construct anaerobic and anoxic tanks for biological nutrient removal, including mixers and internal recycle pumps
- Construct a primary effluent and RAS division structure
- Install two (2) new chemical buildings with chemical feed systems for alum and carbon addition for nutrient removal and associated chemical storage tanks
- Air piping modifications to improve air flow distribution, if hydraulic improvements do not address the air distribution
- Replace oldest turbo-blower
- Replace MCC, moving out of blower room and into new electrical room (included with RAS pumping costs below)

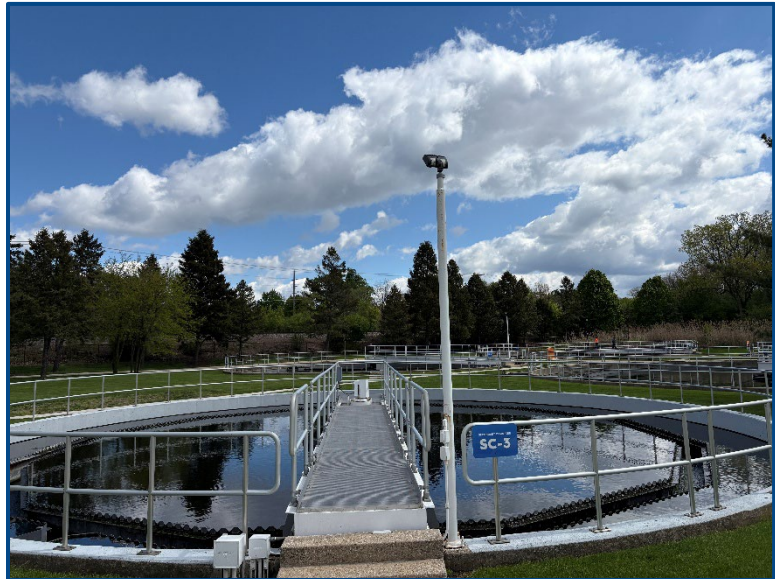
- Performance is inconsistent across the clarifiers due to varying depths and dimensions and the inability to split flow evenly.
- Poor performance results in solids carryover which would blind the downstream filters without the intermediate clarifiers between them.
- The concrete on Clarifiers 1 & 2 is spalling and corroding.
- Algae growth on weirs cannot safely be removed by operators.

- Replace Secondary Clarifiers 1 – 5 with two (2) new clarifiers at the same elevation and capacity as Secondary Clarifiers 8 & 9.
- Replace equipment in Secondary Clarifiers 6 - 9
- Install flow meters and pinch valves on influent pipes to the secondary clarifiers to provide automated, even flow splitting
- Cover weirs (to prevent algae growth)

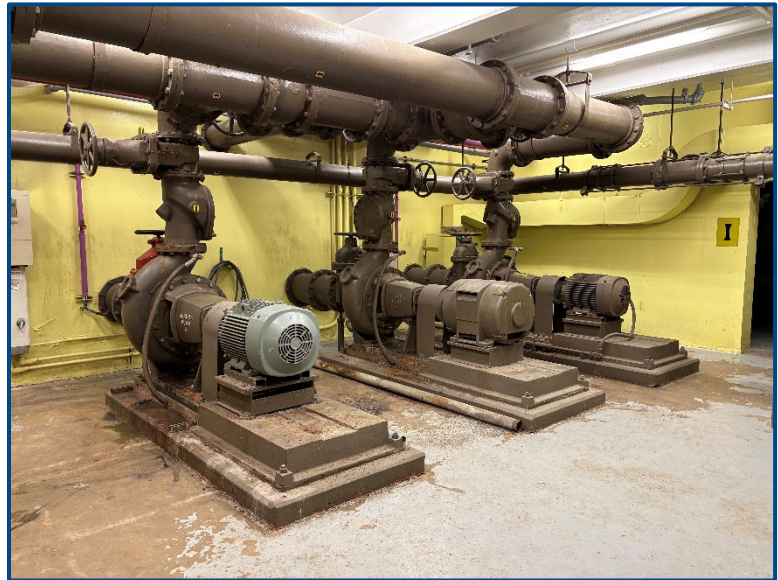
- Located in basement of the Blower Building (I)
- RAS Pumps 1 – 3 (1972)
- Serves Secondary Clarifiers 3 & 5 – 9

- The RAS pumps are reaching the end of their useful life.
- The telescoping valves used to draw sludge off the bottom of the secondary clarifiers make sludge blanket control difficult.

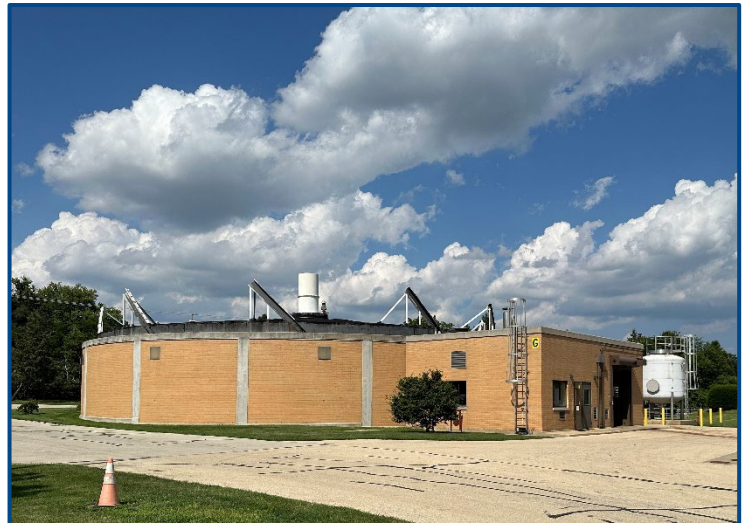
- Built in 1986
- Digester 3 Heat Exchanger
- Miscellaneous sludge pumps
- Miscellaneous digester gas equipment and appurtenances
- MCC 10

Digester 3 Waste Gas Burner (1986)

- The waste gas burner has significant corrosion on it, and the controls need to be replaced.
- The digester cover is at the end of its useful life.
- The 2023 Code Review report recommended that guardrails be installed around the digester and the roof of the control building. Due to the vertical travel of the gas storage cover, the guardrails will need to be mounted on the digester cover instead of the digester wall.

- The MCC is in the hot heat exchanger room and should be replaced due to its age.
- All rooms in the Digester 3 Control Building require explosion proof electrical installations per the current safety code. The electrical installations in the basement and the heat exchanger room will need to be brought up to code when the MCC is replaced.

- Remove the waste gas burner and install a new waste gas burner to replace both the Digester 3 and Digester 5 burners (Note: This cost is not included here - See the Digester 4 & 5 cost estimate.)
- Replace the digester cover
- Replace the MCC, install it in a new electrical room, and address any additional electrical code issues

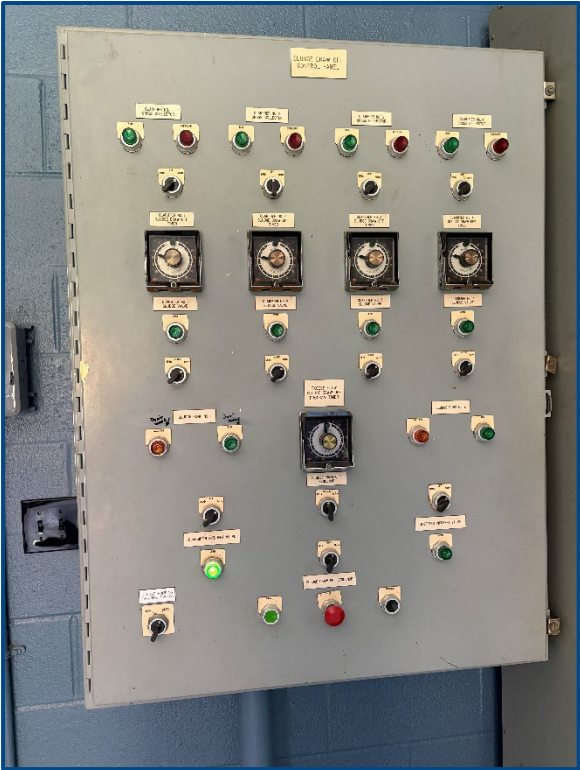
- The clarifier and sludge draw-off controls located in the building are obsolete.
- The MCC needs to be replaced due to age.
- The 2024 derailment of the traveling bridge (sludge scraper) in Excess Flow Clarifiers 1 & 2 has left the equipment out of alignment, making it highly vulnerable to derail again.
- Concrete repairs are needed where the fiberglass effluent troughs come through the walls and around the scraper and at other miscellaneous locations.
- Grout repairs are needed under the rail supports.
- The 2023 Code Review report recommended that guardrails and sidewalk be installed around the Excess Flow Clarifiers.

- Replace the control panels
- Replace MCC 8
- Replace the traveling bridge for Excess Flow Clarifiers 1 & 2
- Rehabilitate the traveling bridge for Excess Flow Clarifiers 3 & 4
- Repair concrete/grout where needed
- Install guardrail and sidewalk around the clarifiers

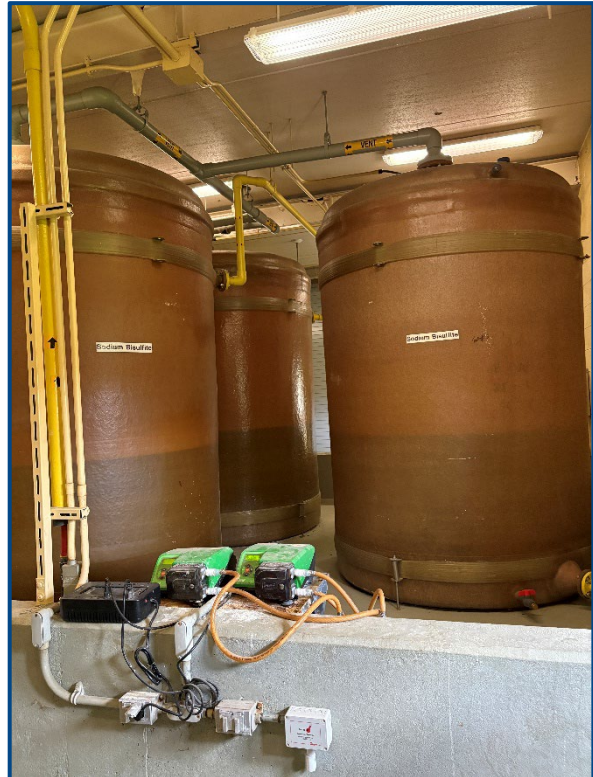
- The bisulfite tanks are inspected and repaired every five years. Due to their age, they are expected to need replacement by the next inspection, which will be in 2030.
- The excess flow effluent from the Intermediate Clarifiers is not dechlorinated, making it difficult to meet both fecal coliform limits and total residual chlorine limits at the same time.

- Replace the existing Bisulfite Storage Tanks
- Install a bisulfite pump skid and piping to serve the Intermediate Clarifiers
- Replace MCC 13

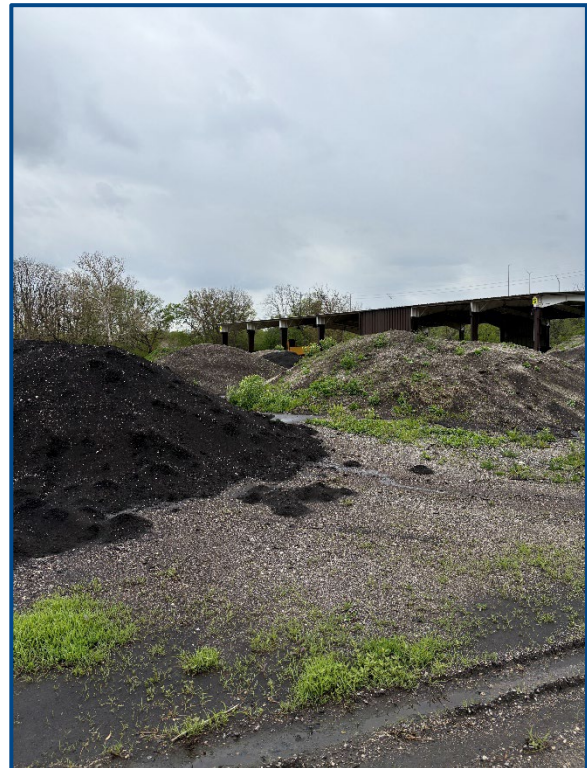
- Dewatered sludge is hauled away for Class B land application on farm fields due to lack of paved areas to age, dry and store sludge. (Class B land application is much more expensive than Class A public distribution.)
- The East Berm Area has asphalt screenings on the ground, making it difficult to move biosolids around.
- Storm runoff from the Big Top and neighboring area discharges into a retention pond that has no outlet.

- Pave the East Berm Area to provide additional aging/storage of dewatered sludge.
- Reroute stormwater to the head of the plant.

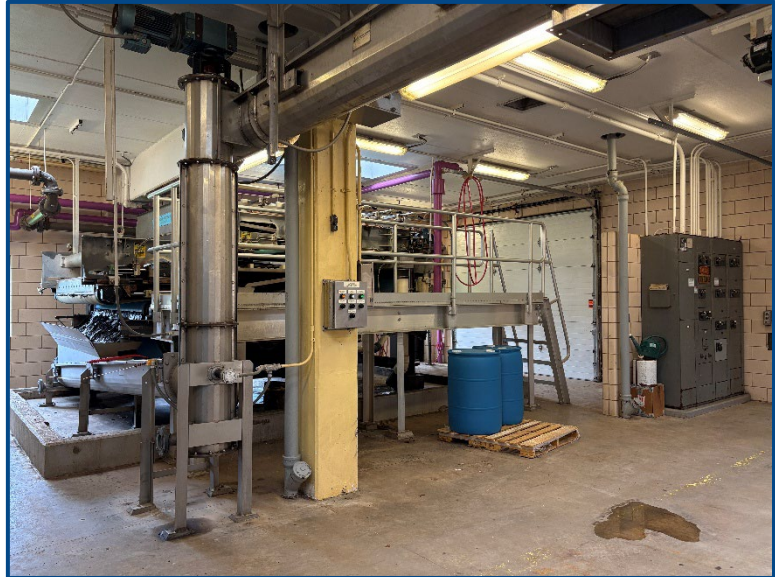
Belt Filter Press Building (A)

- Built in 1986
- Belt Filter Press (2009)
- Belt Press Sludge Feed Pump 1 (2021)
- Belt Press Sludge Feed Pump 2 (2026)
- Polymer System (2017)
- Conveyor (2009)
- MCC 9 (1987)

- Since the District started co-digesting with hauled grease waste, the sludge has been harder to dewater.
- Future phosphorus removal will increase sludge production. In addition, sludge produced from biological phosphorus removal will be more difficult to dewater.
- The MCC is in the wet, corrosive environment with the belt filter press.
- When the belt filter press is out of service for maintenance, digested sludge is sent to drying beds and/or lagoons, taking up space needed for other purposes.
- The belt filter press is run during the day, four (4) days per week. The filtrate, which is recycled to the incoming sewer, is very high in ammonia, resulting in slug loads to the WWTC.
- The sludge hopper room, which is an explosion proof area, is connected to the main room.

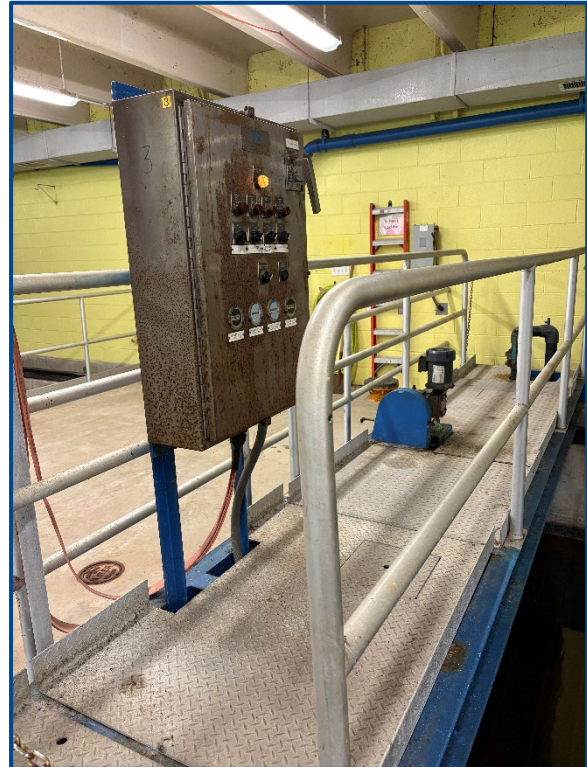
- The traveling bridges (backwash carriages) are in poor condition and need to be replaced.
- The control cabinets are in poor condition also, and some parts are obsolete.

- The flow split is not balanced with Sand Filters 5 & 6 receiving proportionally more flow than Sand Filters 1 – 4.
- Total phosphorus limit of 0.35 mg/L will become effective May 1, 2040, with process improvements required to be in operation by May 1, 2038. The existing sand filters will not provide sufficient treatment to ensure the future phosphorus limit is always met.

- All electrical equipment is rusting due to the damp, corrosive environment.
- Parts are obsolete for MCC 6A. MCC 6A has openings on bucket cover plates, which create hazardous conditions.

- Demolish the existing sand filters
- Install disc filters inside the existing building to meet future phosphorus limits
- Replace the MCCs in a new clean electrical room
